BEHAVIOR OF CONCRETE T-BEAMS WITH
WELDED WIRE FABRIC WEB REINFORCEMENT

A THESIS

SUBMITTED TO THE FACULTY OF GRADUATE STUDIES AND RESEARCH
IN PARTIAL FULFILLMENT OF THE REQUIREMENTS FOR THE DEGREE
OF MASTER OF SCIENCE
CIVIL ENGINEERING

FALL 1982

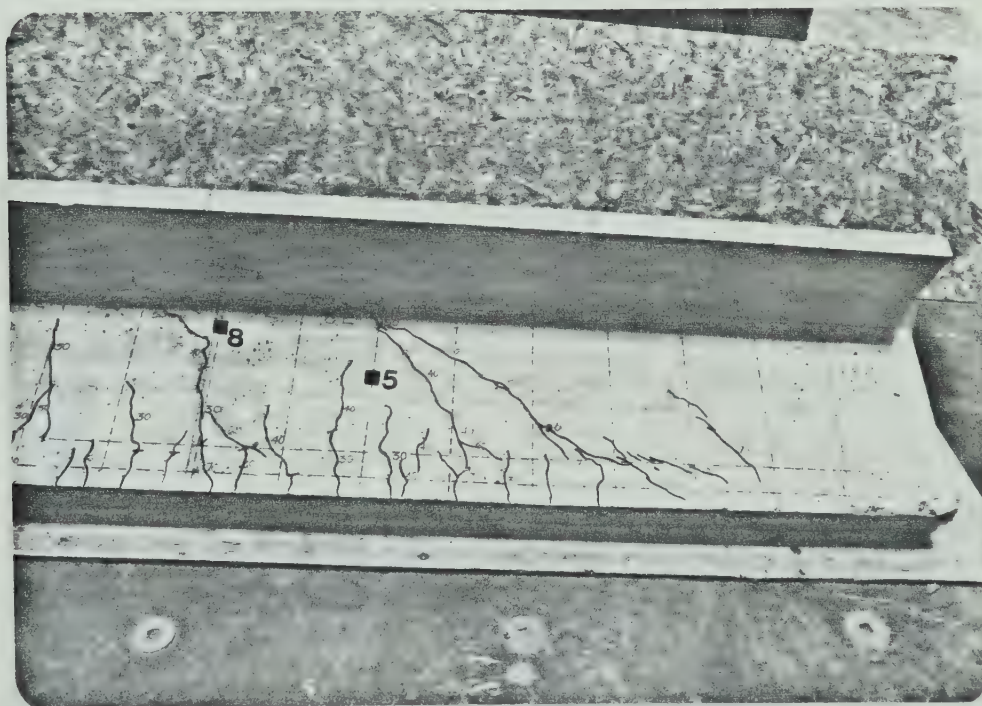
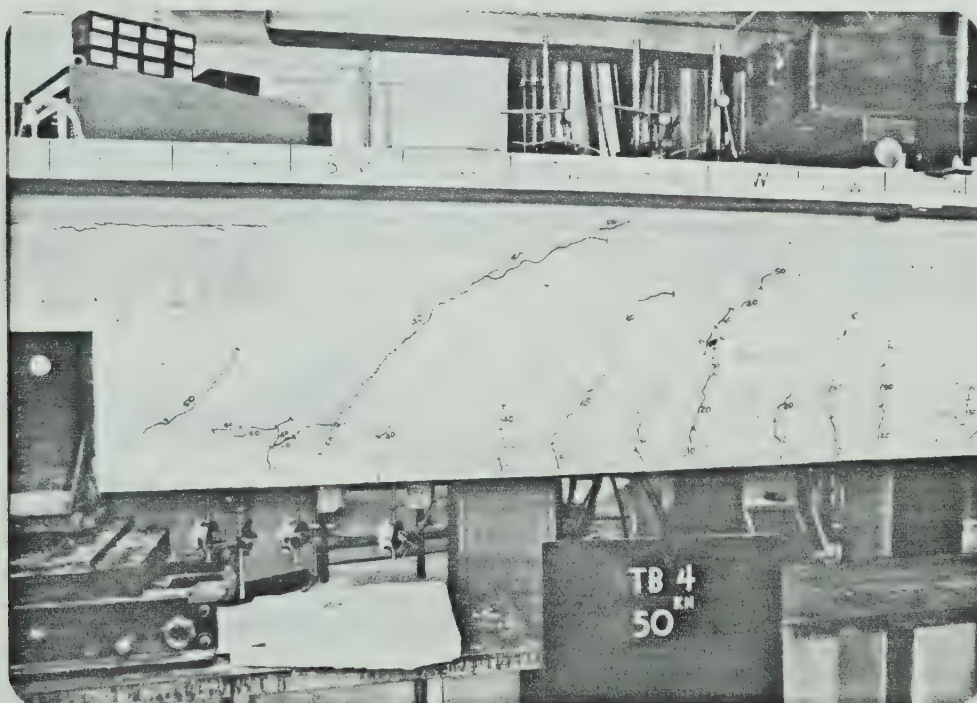
FIGURE 6.1 - Cracking in east shear span of TB 4
at $P = 30$ kN

FIGURE 6.2 - Cracking in east shear span of TB 4
at $P = 50$ kN

FIGURE 6.3 - Cracking in east shear span of TB 4 at ultimate load ($P_{ult} = 80 \text{ kN}$) with crack numbers shown

FIGURE 6.4 - Cracking in east shear span of TB 4 after testing with strain gauge locations shown

FIGURE 6.5 - Cracking in west shear span of TB 4
at $P = 30$ kN

FIGURE 6.6 - Cracking in west shear span of TB 4
at $P = 50$ kN

FIGURE 6.7 - Cracking in west shear span of TB 4 at ultimate load ($P_{ult} = 80 \text{ kN}$) with crack numbers shown

FIGURE 6.8 - Cracking in west shear span of TB 4 after testing with strain gauge locations shown

FIGURE 6.9 - Cracking in pure moment region of TB 4 after testing with crack numbers shown

Photographs of TB 2 and TB 4 during loading and after failure are shown in Figures 6.1 to 6.18. Beam TB 2 failed at 70 kN (15.7 kips) and TB 4 failed at a load of 80 kN (18.0 kips). The WWF web reinforcement in TB 2 had D2.5 vertical wires at 152 mm (6 inch) spacing while TB 4 had D2.9 vertical wires with the same spacing. In both cases, the WWF mats had two horizontal cross-wires top and bottom. It should be noted that TB 4 failed immediately after all measurements were taken at the 80 kN load level while TB 2 failed as measurements were being taken at the 70 kN load level.

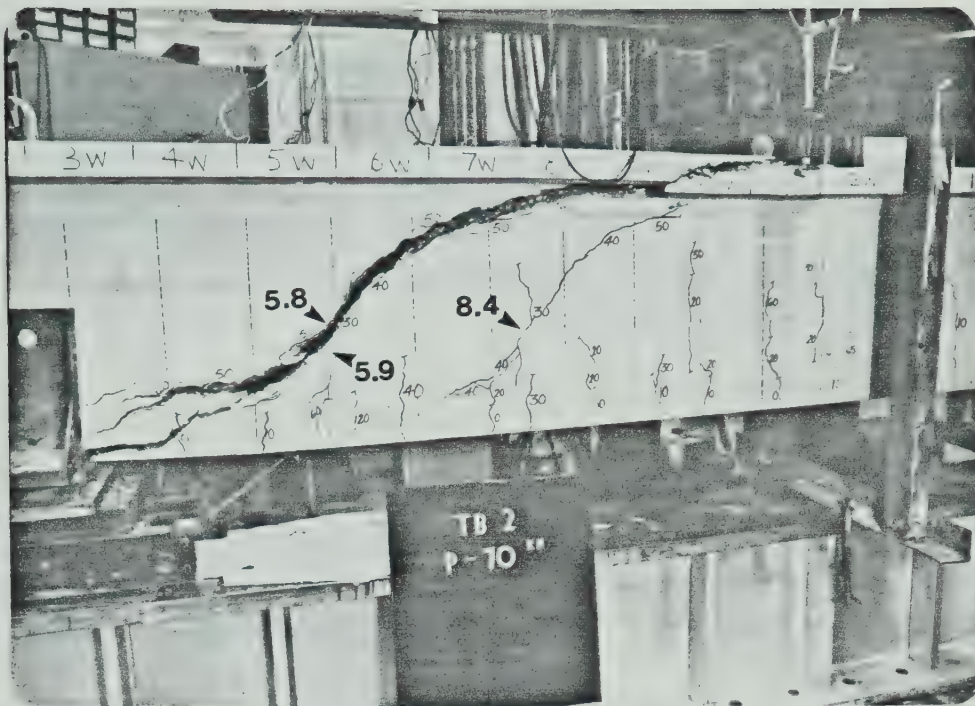
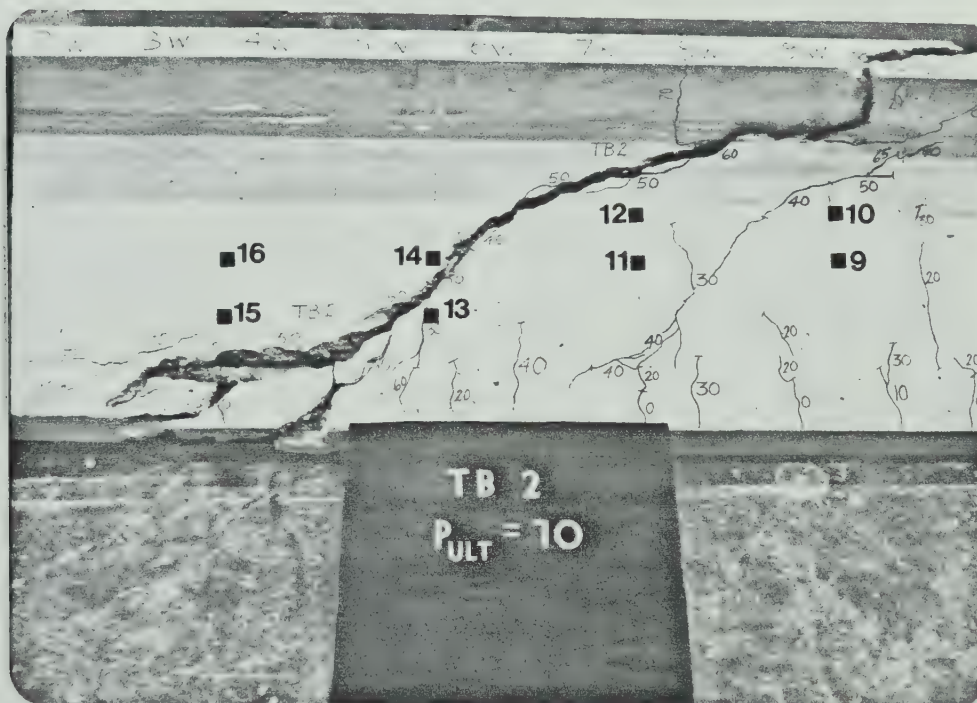
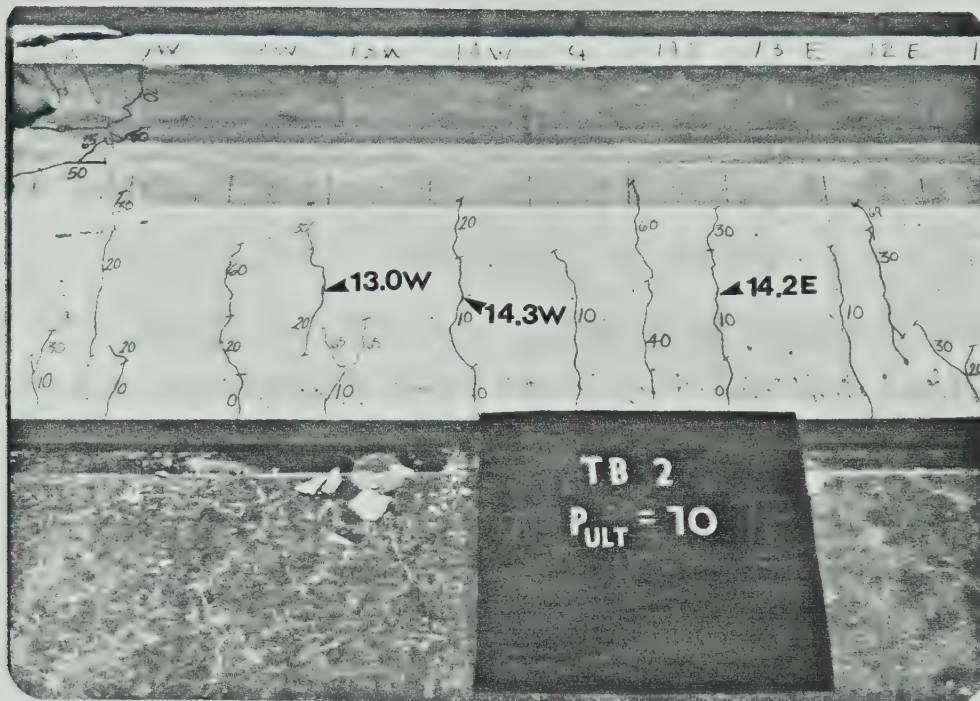
FIGURE 6.10 - Cracking in west shear span of TB 2 at $P = 30 \text{ kN}$

FIGURE 6.11 - Cracking in west shear span of TB 2 at $P = 50 \text{ kN}$

FIGURE 6.12 - Cracking in west shear span of TB 2 at ultimate load ($P_{ult} = 70 \text{ kN}$) with crack numbers shown

FIGURE 6.13 - Cracking in west shear span of TB 2 after testing with strain gauge locations shown

FIGURE 6.14 - Cracking in east shear span of TB 2 at $P = 30 \text{ kN}$

FIGURE 6.15 - Cracking in east shear span of TB 2 at $P = 50 \text{ kN}$

FIGURE 6.16 - Cracking in east shear span of TB 2 at ultimate load ($P_{ult} = 70 \text{ kN}$) with crack numbers shown

FIGURE 6.17 - Cracking in east shear span of TB 2 after testing with strain gauge locations shown

FIGURE 6.18 - Cracking in pure moment region of TB 2 after testing with crack numbers shown.

In TB 2, 16 strain gauges were installed but only 11 gave reliable readings. Four of these were in the east shear span (gauges 2, 5, 6 and 7) and seven in the west span (gauges 9, 10, 12, 13, 14, 15 and 16). Two gauges were mounted on each stirrup that was monitored. These gauges were located as shown in Figures 6.13 and 6.17. Figures 6.20 and 6.21 plot stirrup strain versus load using the strain gauges that gave the highest readings for each stirrup monitored. Strain gauges 14 in the west span and 5 in the east span recorded the largest strains. These gauges were installed on well anchored stirrups that were crossed by the widest inclined cracks in the region between the top of the main reinforcement and the web-to-flange transition. Because these stirrups were well anchored on each side of the cracks, they were able to develop larger loads, as was borne out by the measured strains. The gauges that gave lower readings were located on stirrups that were either crossed by narrow inclined cracks (gauge 10 in Figure 6.13) or they were crossed by the wider inclined cracks in the regions near the web-to-flange transition (gauge 7 in Figure 6.17) or near the main reinforcement (gauge 15 in Figure 6.13).
